METAL / NONMETAL Near Miss Incident

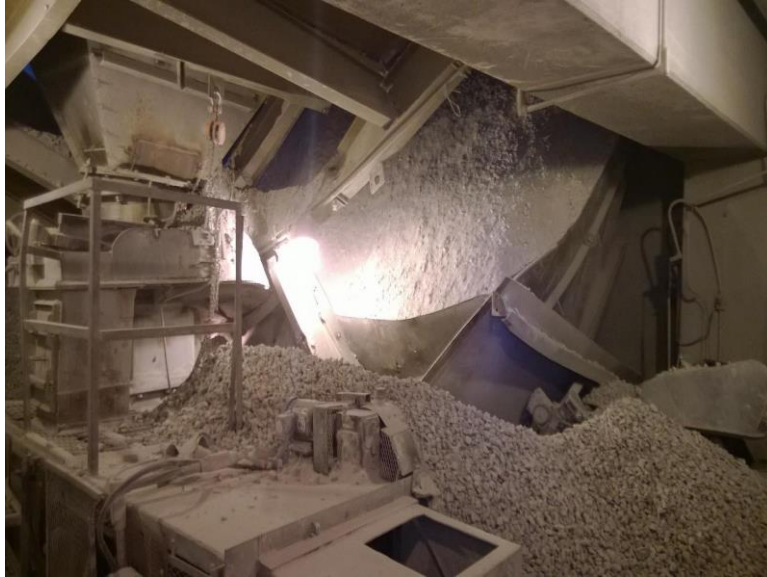
Cement Plant – A 100 ton “Sand Bin” failed inside this plant. The Sand Bin collapsed through the mill floor it was on and came to rest in the basement. The failure occurred between shifts where normally 5 miners would have been assigned to work. No injuries were reported.

- Examine your work places for all possible hazards and correct them before you perform work.
- Conduct structural inspections periodically.
- Routinely examine metal structures for indications of weakened structural soundness (corrosion, fatigue cracks, bent/buckling beams, braces or columns, loose/missing connectors, broken welds, etc.).
- Keep corrosive material spillage/build-up removed from metal structures.
- Report all areas where indications of structural weakness are found.
